K-89

Fair Hope Farm
Quaker Neck
1st Quarter 19th Century

INVENTORY FORM FOR STATE HISTORIC SITES SURVEY

Fair Hope

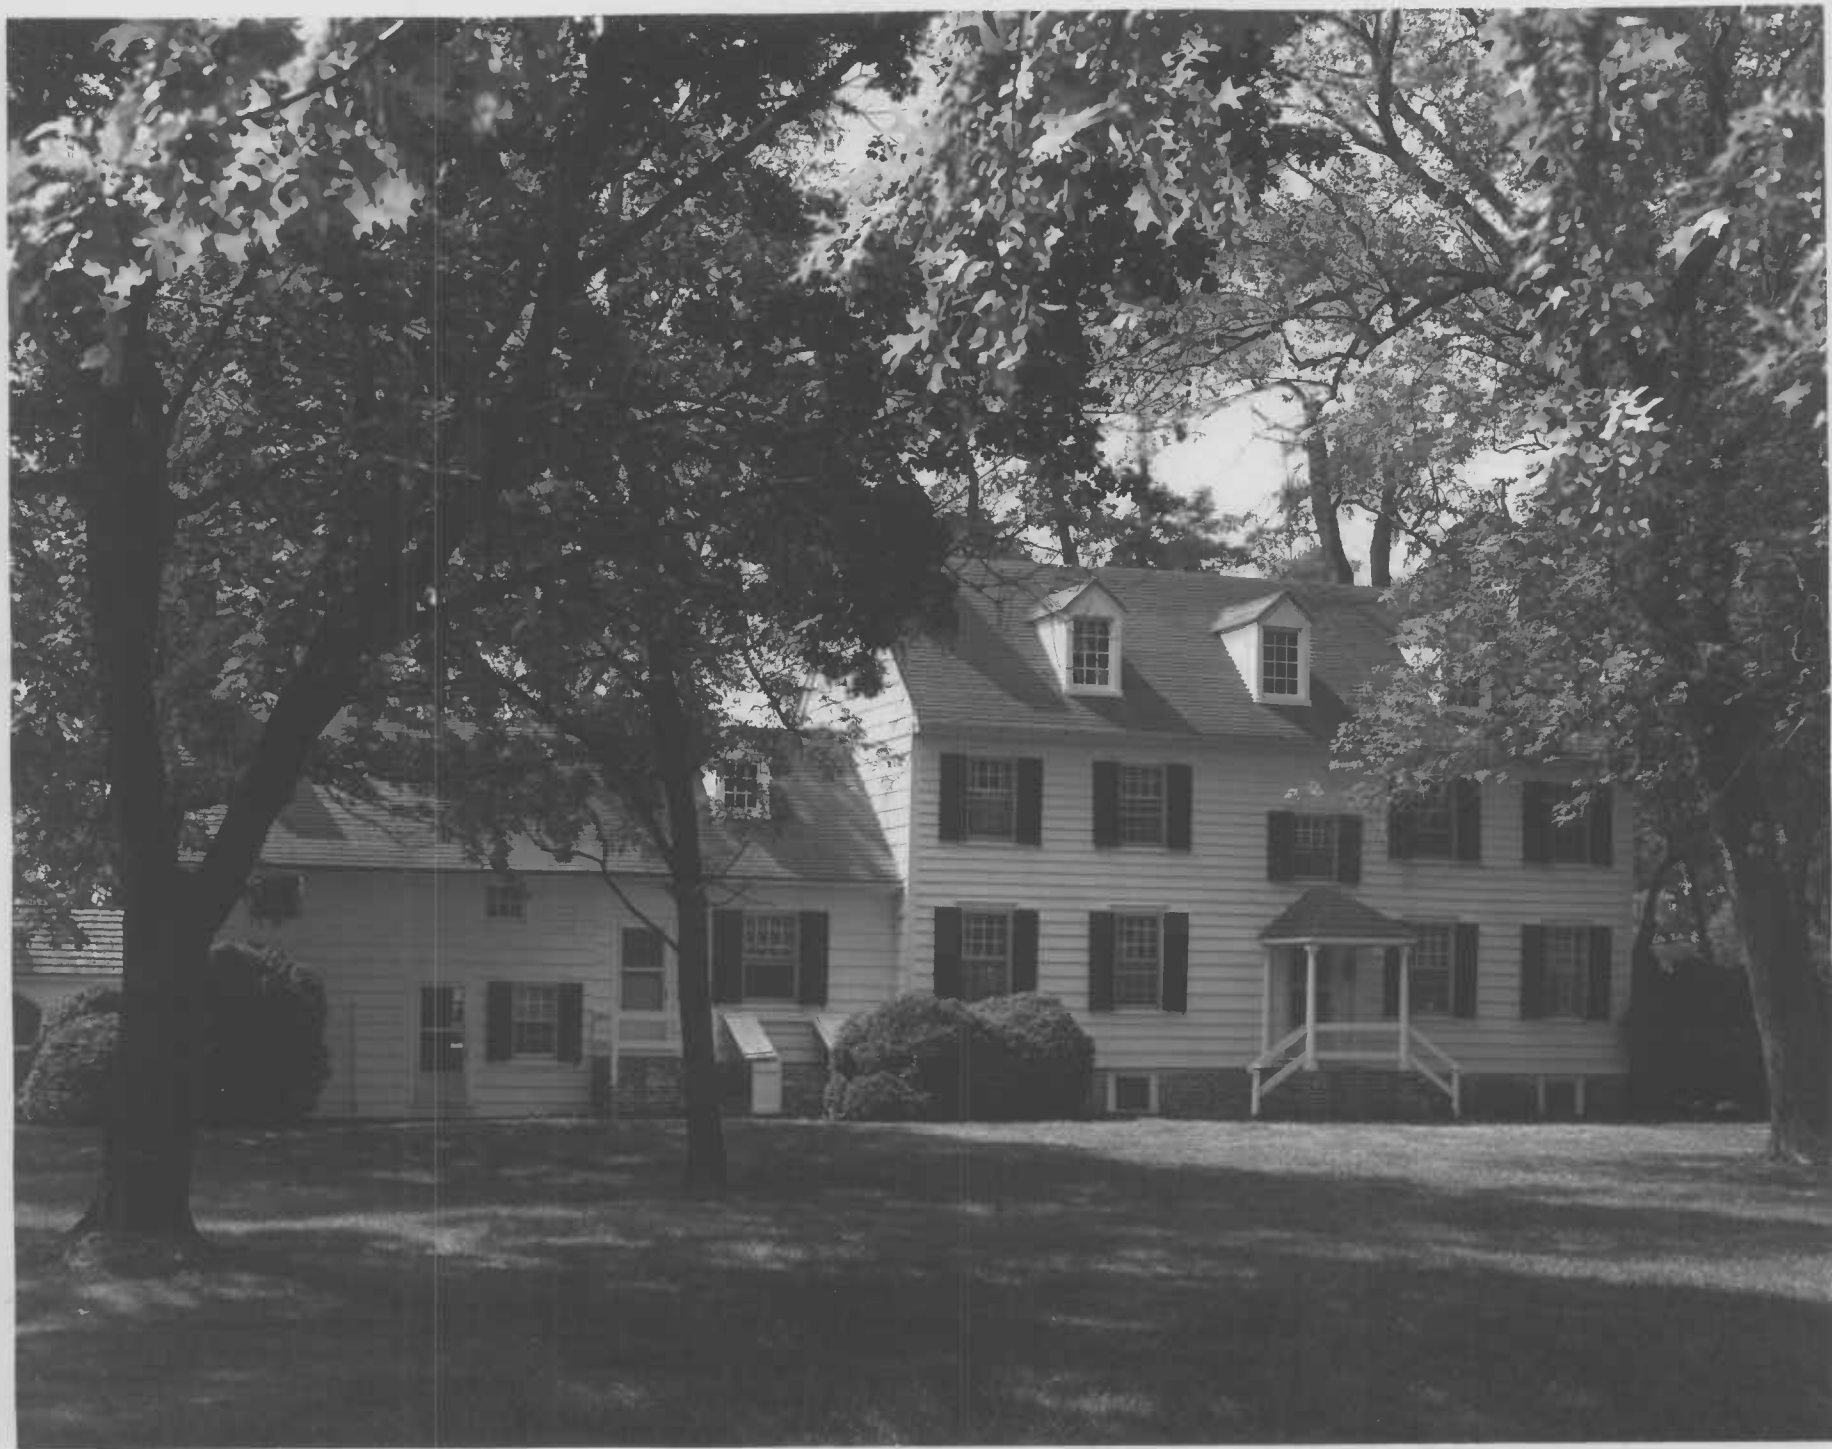
FRONT FROM NORTH

The main house is two and one-half stories tall with high brick foundation and gable roof with three gable dormers. This is a five bay frame house with a central hall and a series of wings telescoping to the southeast side. The building was restored and enlarged by the present owner in 1934 with assistance of Brognaid Okie, a Philadelphia architect.

Windows are evenly spaced on the main house. On the approach front are 12/12 sash windows with narrow trim made up of composite moldings of the type common in the Federal period. There is a window at the stair landing and below this the main entrance which has an entrance porch with conical roof and round columns. The roof is covered with black asphalt shingles. It is finished with a denticulated box cornice. The dormer windows have diagonally boarded cheeks.

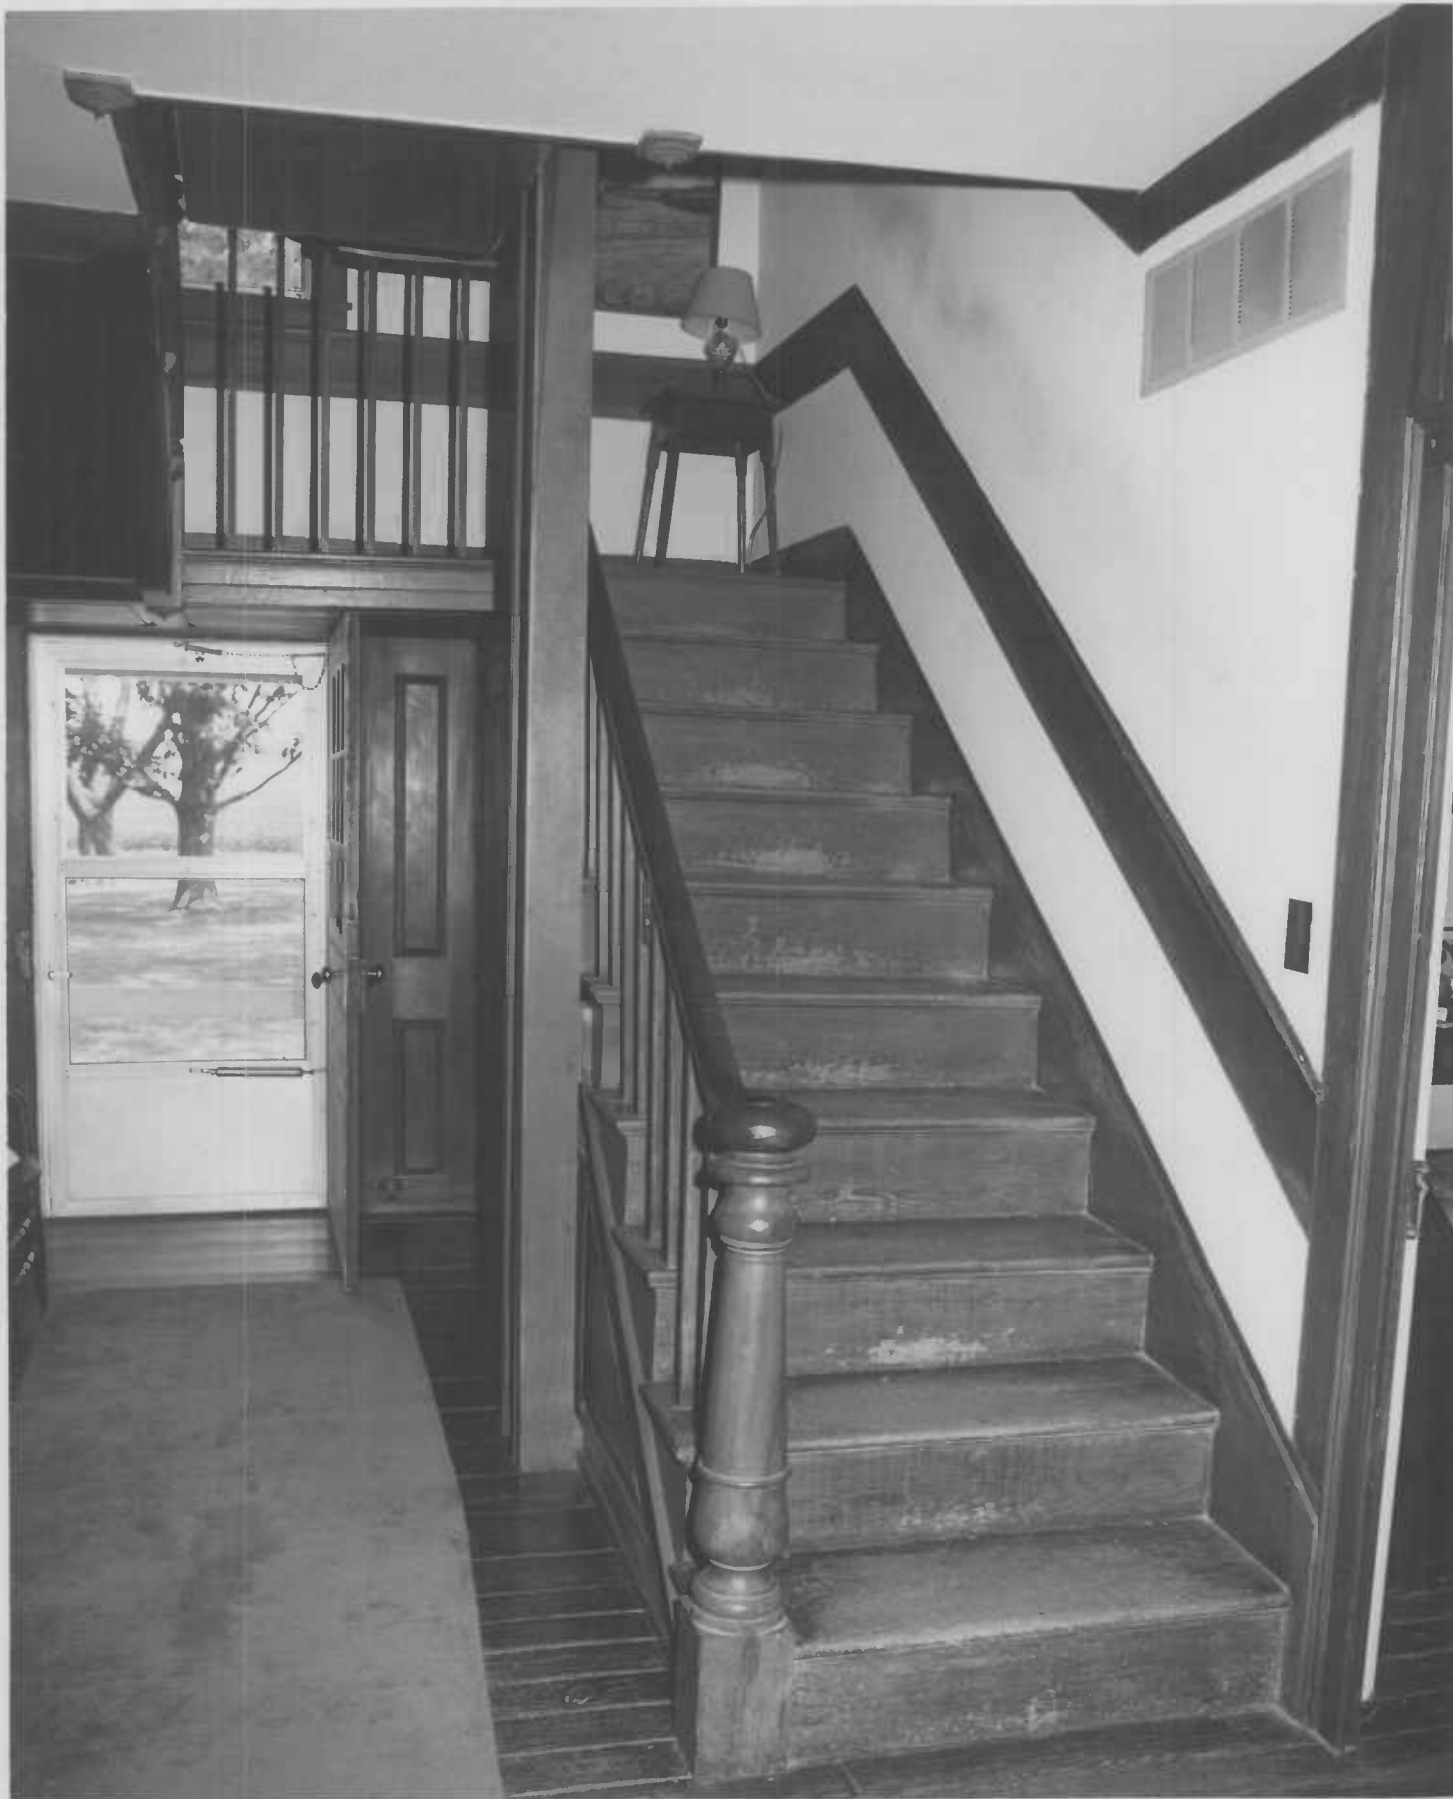
STAIRWAY

The dining room is refuted to be the earliest part of the house. It has a fine early 19th century yellow pine corner cupboard. The details of the stair in the main section appear to date from the 1840's, but the rest of the millwork is the product of Brognard Oakie, the Pennsylvania architect responsible for remodeling the house for Mr. and Mrs. Charles Stokes in 1935.¹

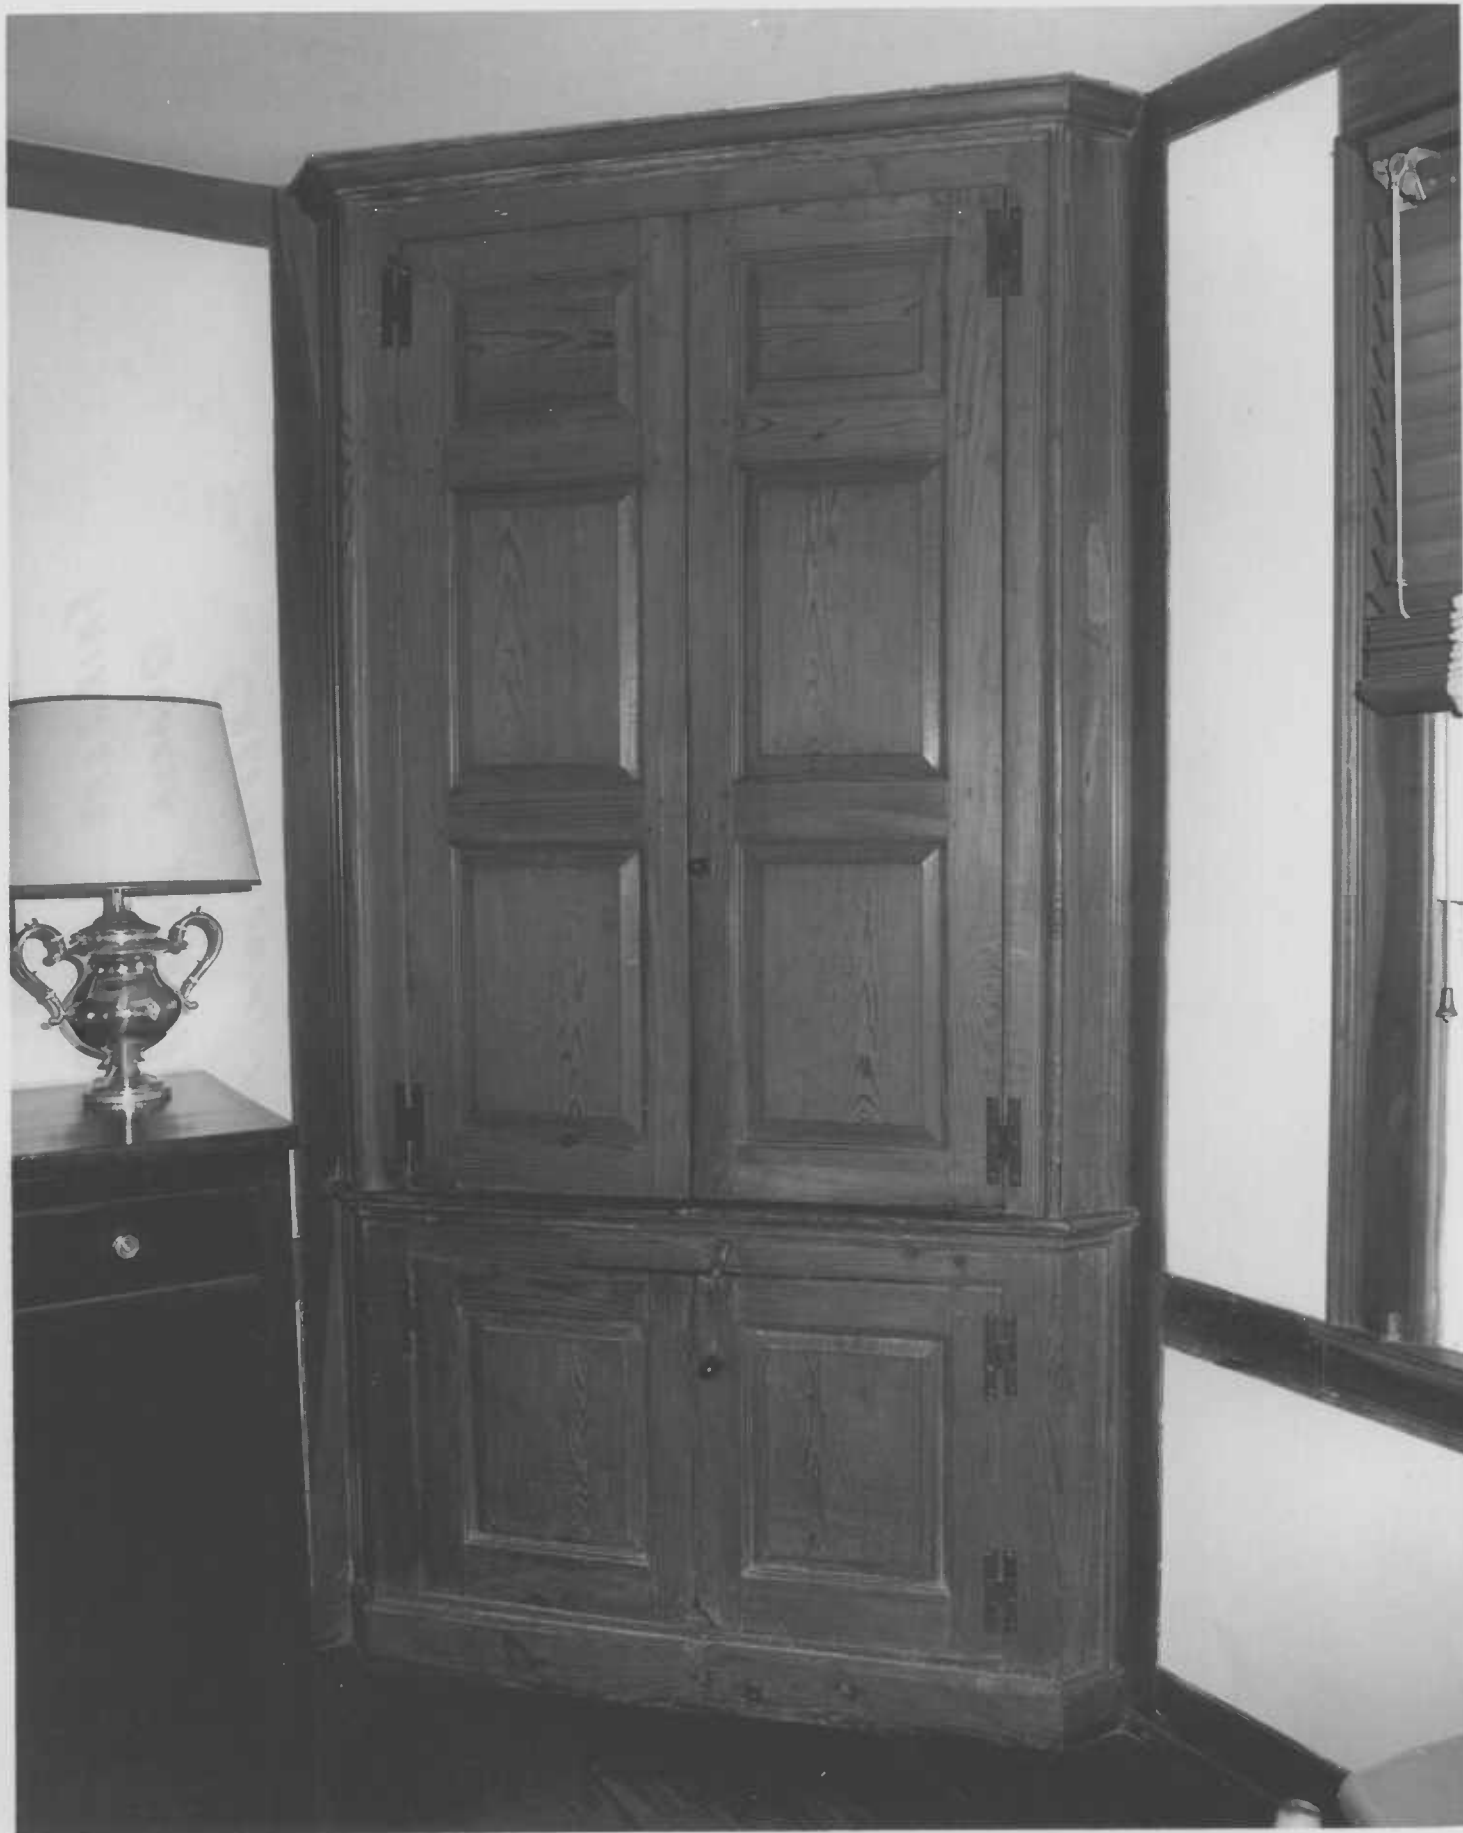
ORIGINAL CUPBOARD FIRST FLOOR

The interior paneling replaces the original interior finish which was lost. Its design is based upon a corner cupboard which remains in the dining room. Major down stairs rooms have raised and beveled paneled walls, that in the northeast room being natural cherry.
